# Hip Implant Corrosion Mechanisms and Effects:

Mechanically Assisted Corrosion, Crevices and Voltage Effects

Jeremy L. Gilbert, Ph.D., FBSE
Professor of Biomaterials
Syracuse Biomaterials Institute
Department of Biomedical and Chemical Engineering
Syracuse University
Syracuse, NY 13244

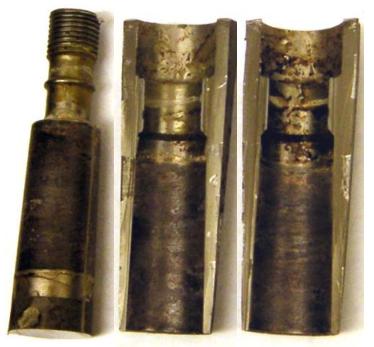
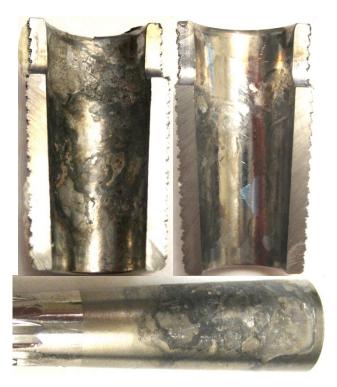
#### Modular Body Interfaces: Ti6Al4V/Ti6Al4V Interfaces: 2009

Company A

Infection-related

22 months

Company B► Infection-related► Unknown -1?

Company C

→ Pain

→ 27 months
